Sideslip Anomaly

Summary

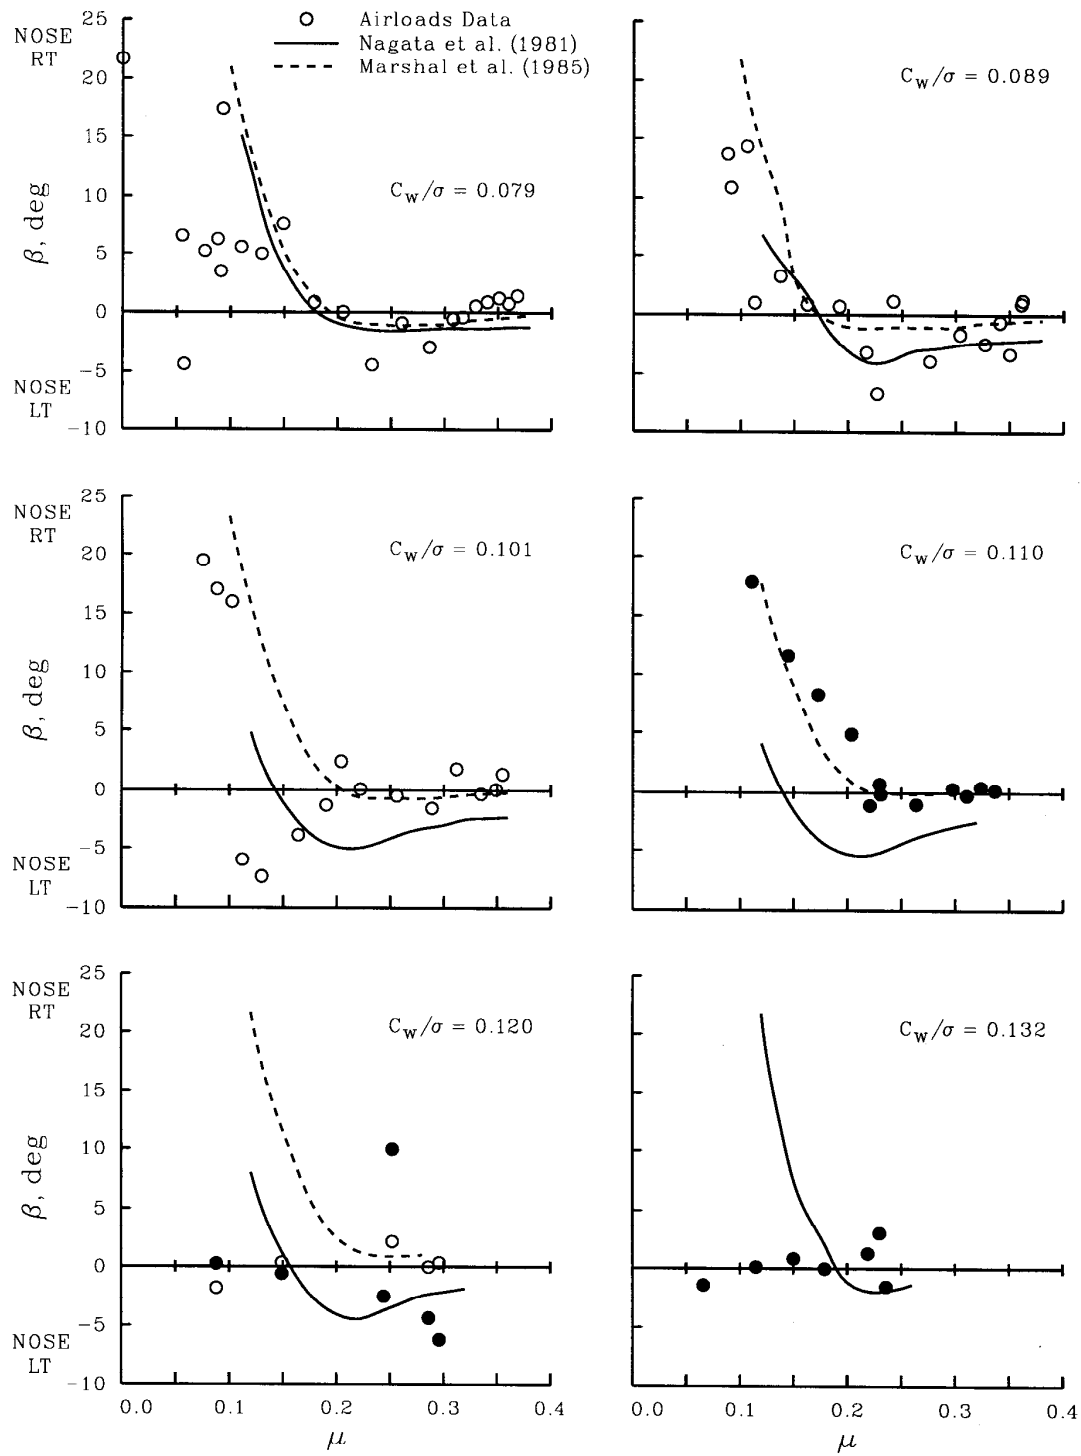
Figure 1 – Comparison of measured sideslip angle for six level flight performance conditions with measurements obtained by Nagata et al. (1981) and Marshall et al. (1985). Solid circles have been shifted by -39.77 deg.

The bias value for the sideslip angle determined in the pre- and post-flight static calibrations for Flights 89 and 90 is significantly offset from all other flights in the Airloads Program. The bias offset of -39.77 deg is quite noticeable in the data. The measured sideslip values shown here for the three highest weight coefficients have been arbitrarily shifted by -39.77 deg on an ad hoc basis. However, this bias shift was not used for all test points as can be seen for five of the airspeeds for $C_w/\sigma = 0.12$. It appears that the bias shift that occurred on these two flights was in some cases intermittent. The cause of this anomaly is unknown.

The bias shift in the pre- and post-static calibrations encountered on Flights 89 and 90 is not seen on any other flight and hence the problem with this bias shift appears to be restricted to these two flights. However, this bias shift did not occur for all counters on these flights and it is possible that a related shift has occurred for individual counters on other flights. No systematic search has been made for other flights to see if this anomaly occurs for other counters. Although other anomalous cases have not been found, the use of the sideslip measurement for other flights needs to be done with some caution.
